Ruby Gulch Tailings Reclamation

- Generated by the Whitcomb Mill
- Cyanide Vat leach tailings dumped in Ruby Gulch during early mining
- Used as construction material for area projects
- 1 million cubic yards left in the drainage at mine closure

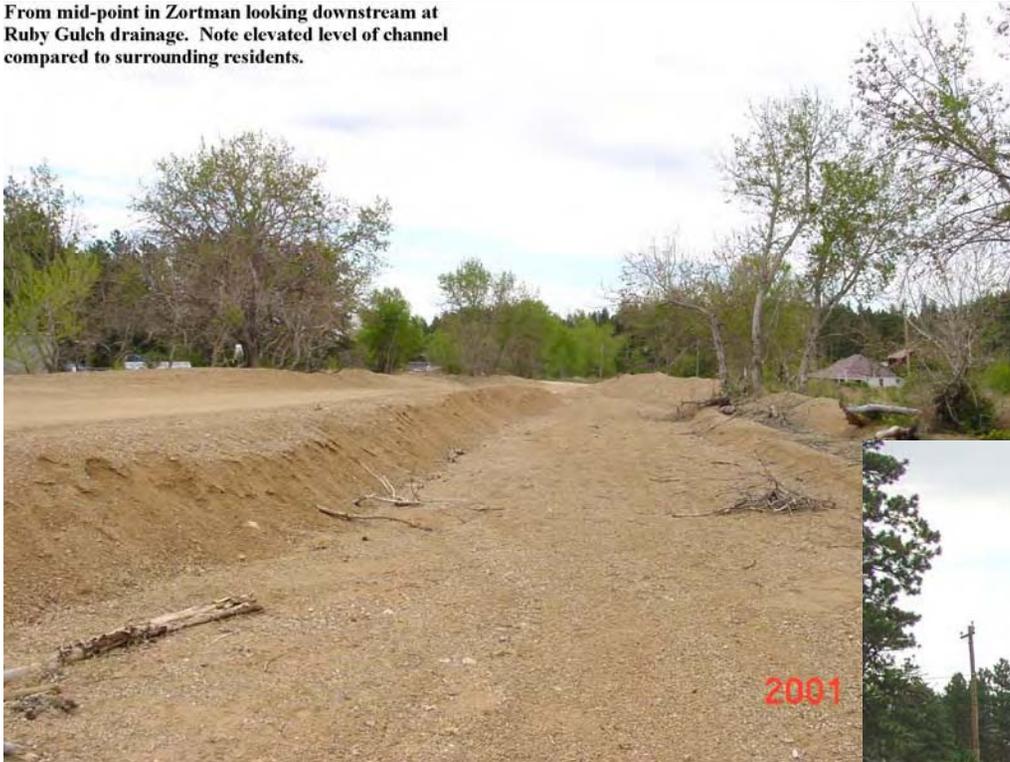
From mid-point in Zortman looking downstream at Ruby Gulch drainage. Note elevated level of channel compared to surrounding residents.

**Zortman Townsite Before
Tailing Removal, May 2001**

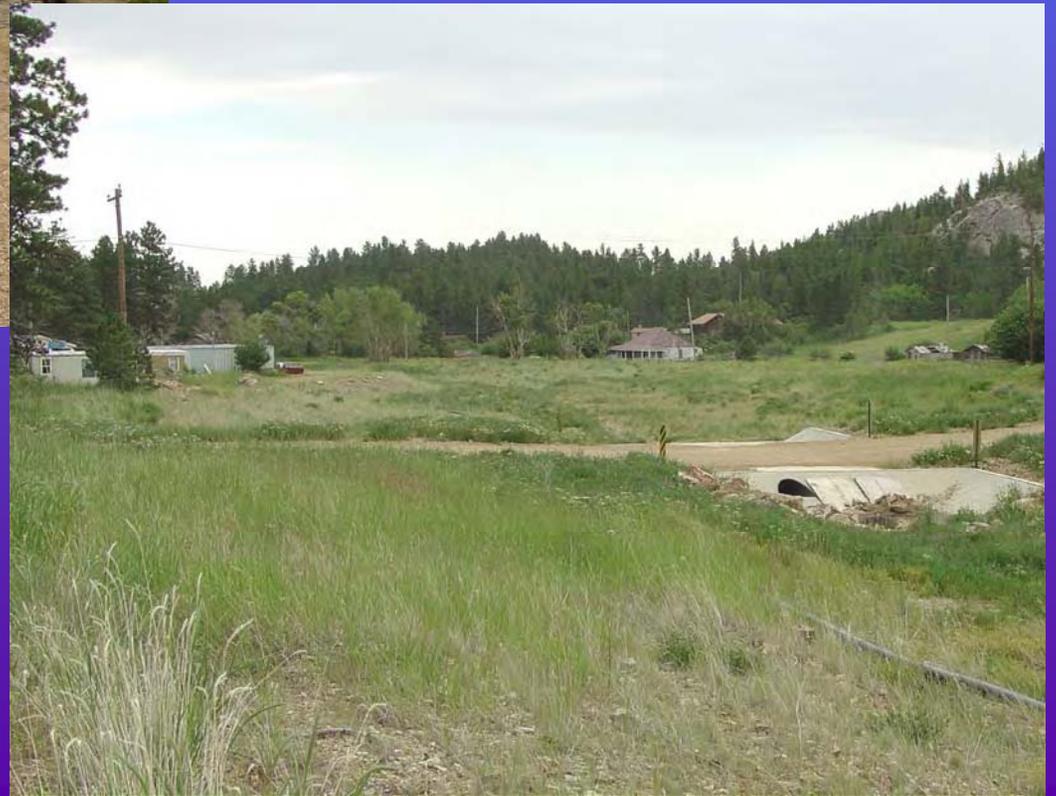
**Zortman Townsite After Tailing
Removal and Streambed
Restoration, July 2005**

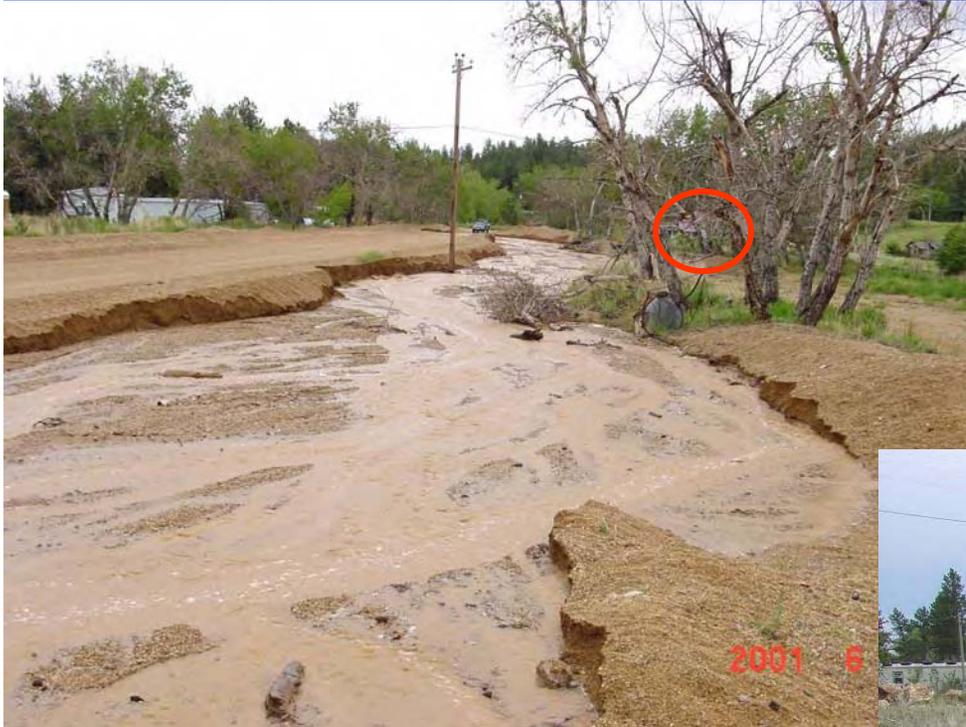
Ruby Gulch flowing through town of Zortman – June 2001

Red circle is same residence in each photo for reference

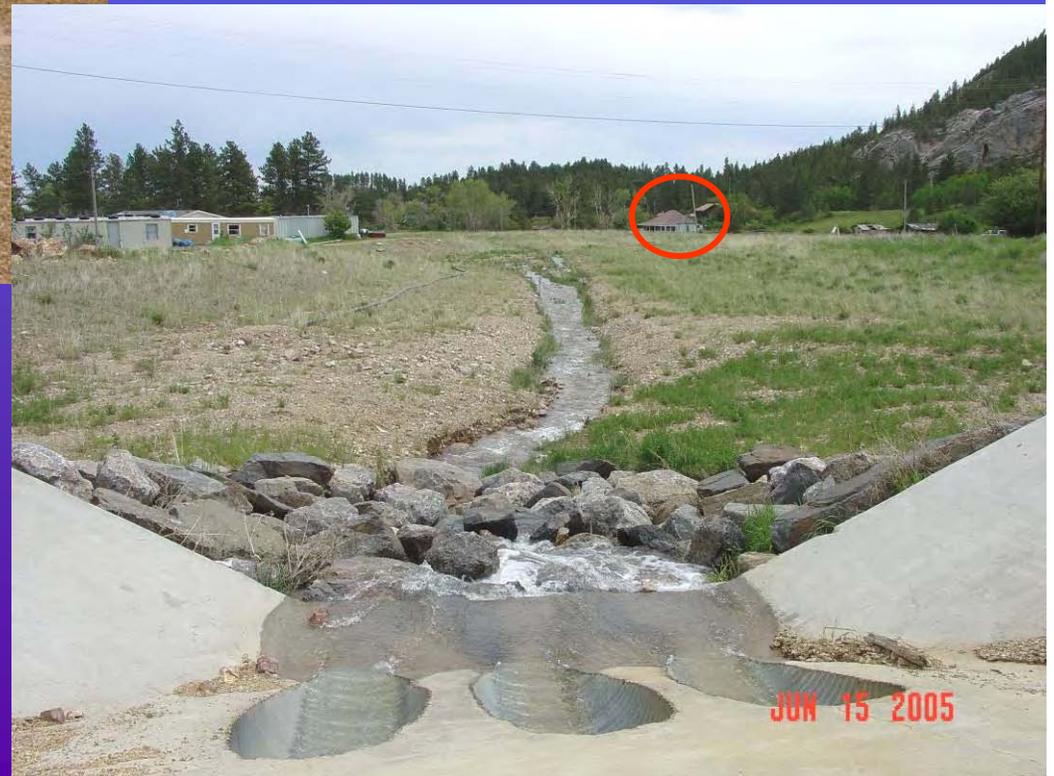
Ruby Gulch flowing through town of Zortman – June 2005

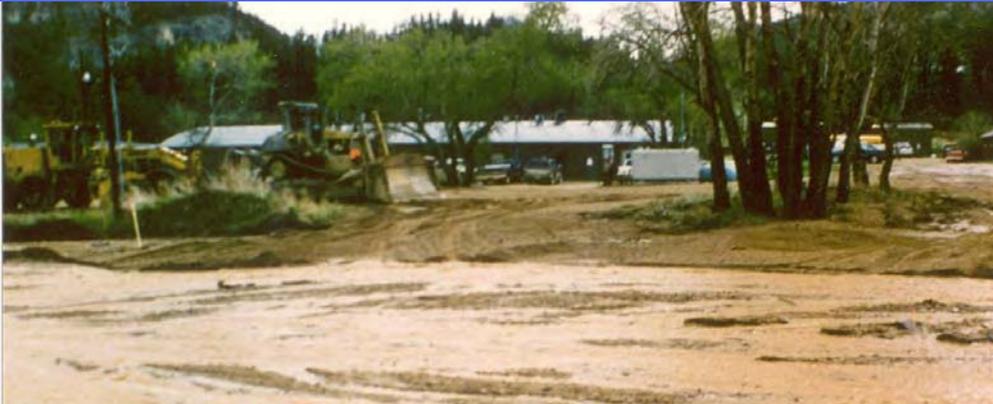
**June 2005- Ruby Gulch
near old mine office**

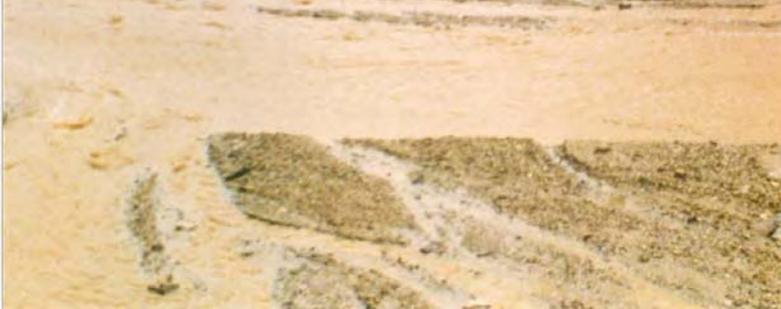
**September 1997- Ruby
Gulch near old mine office**
